**DEPARTMENT OF TRANSPORTATION**

Contract #: 04-0120F4Cty: SF/ALA Rte: 80 PM: 13.2/13.9File #: 1.28**WELDING INSPECTION REPORT****Resident Engineer:** Pursell, Gary**Address:** 333 Burma Road**City:** Oakland, CA 94607**Report No:** WIR-000591**Date Inspected:** 09-Oct-2007**Project Name:** SAS Superstructure**OSM Arrival Time:** 700**Prime Contractor:** American Bridge/Fluor Enterprises, a JV**OSM Departure Time:** 1700**Contractor:** American Bridge/Fluor Enterprises, a JV**Location:** Benicia, CA**CWI Name:** Michael Johnson**CWI Present:** Yes No**Inspected CWI report:** Yes No N/A**Rod Oven in Use:** Yes No N/A**Electrode to specification:** Yes No N/A**Weld Procedures Followed:** Yes No N/A**Qualified Welders:** Yes No N/A**Verified Joint Fit-up:** Yes No N/A**Approved Drawings:** Yes No N/A**Approved WPS:** Yes No N/A**Delayed / Cancelled:** Yes No N/A**Bridge No:** 34-0006**Component:** Procedure Qualification Record (PQR) Test**Summary of Items Observed:**

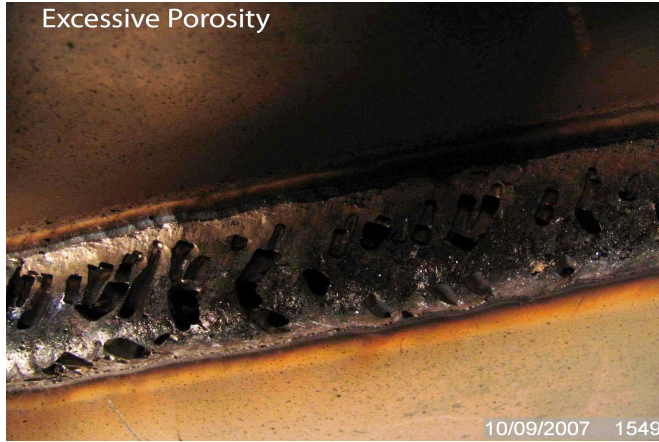
In the beginning of the shift the QA Inspector observed the welding operators set up (2) non-PQR test plates and practice welding on them. The welder later in the shift the QA Inspector observed the welding operators deposit (4) weld passes onto PQR test plate known as ABF-PQR-015-1 in the 4G position. The QA Inspector observed that the welders continued to experience problems with porosity during welding and numerous weld passes were removed by grinding prior to depositing successive weld passes. The welders used 1/16 inch diameter (1.6mm) ESAB 70 Ultra-Plus E70T-1 (FCAW-G) welding wire and 90% Argon/10% Carbon Dioxide gas. The welding operators utilized an ESAB power source, wire feeder and mechanical welding device to deposit these welds. Later in the shift the QA Inspector was informed by ABF that the above mentioned PQR test plate will not undergo any further welding. See photo below for additional information.
